# Case Study

## HARLEQUINS RFC, THE STOOP SOUTH STAND

**Client:** Harlequins RFC

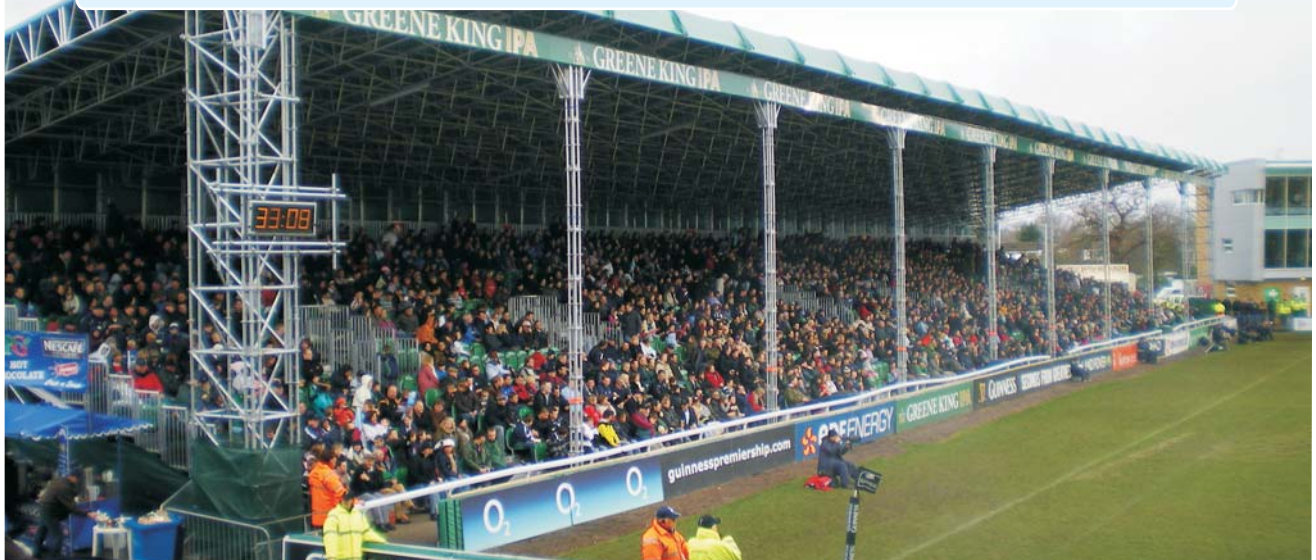
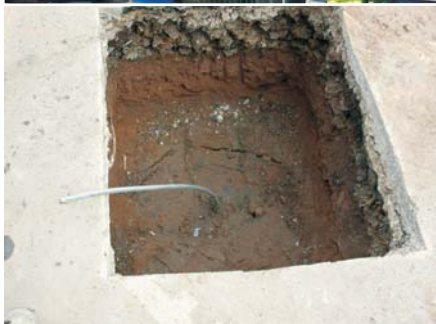
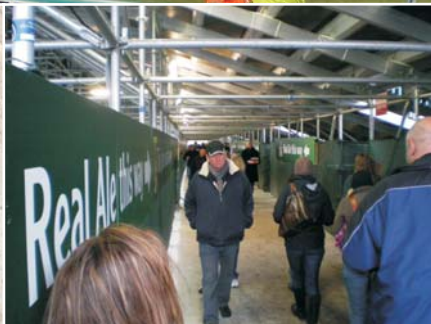
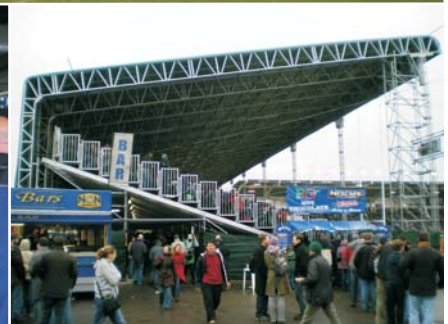
Following site testing it was determined that the B10 anchor installed to a depth of 4m, loadlocked and then tied into the foundation block reinforcement would be suitable. The concrete of the foundation could then be poured, providing a securely anchored foundation point for the attachment of the roof supports. The rear row of smaller B6 anchors were terminated with a loop, allowing the roof structure to be directly attached.

**Anchor System:** B10TC galvanised spheroidal graphite iron anchor c/w 5m of 16mm Ø galvanised steel wire tendon, 200mm x 200mm galvanised steel load plate and 16mm steel wedge grip. B06TC galvanised spheroidal graphite iron anchor c/w 5m of 12mm Ø galvanised steel wire tendon and three wire rope grips.
